OSA -0599-68

Subject: LOCAL MODIFICATION TO P/N DN55000 PARACHUTE

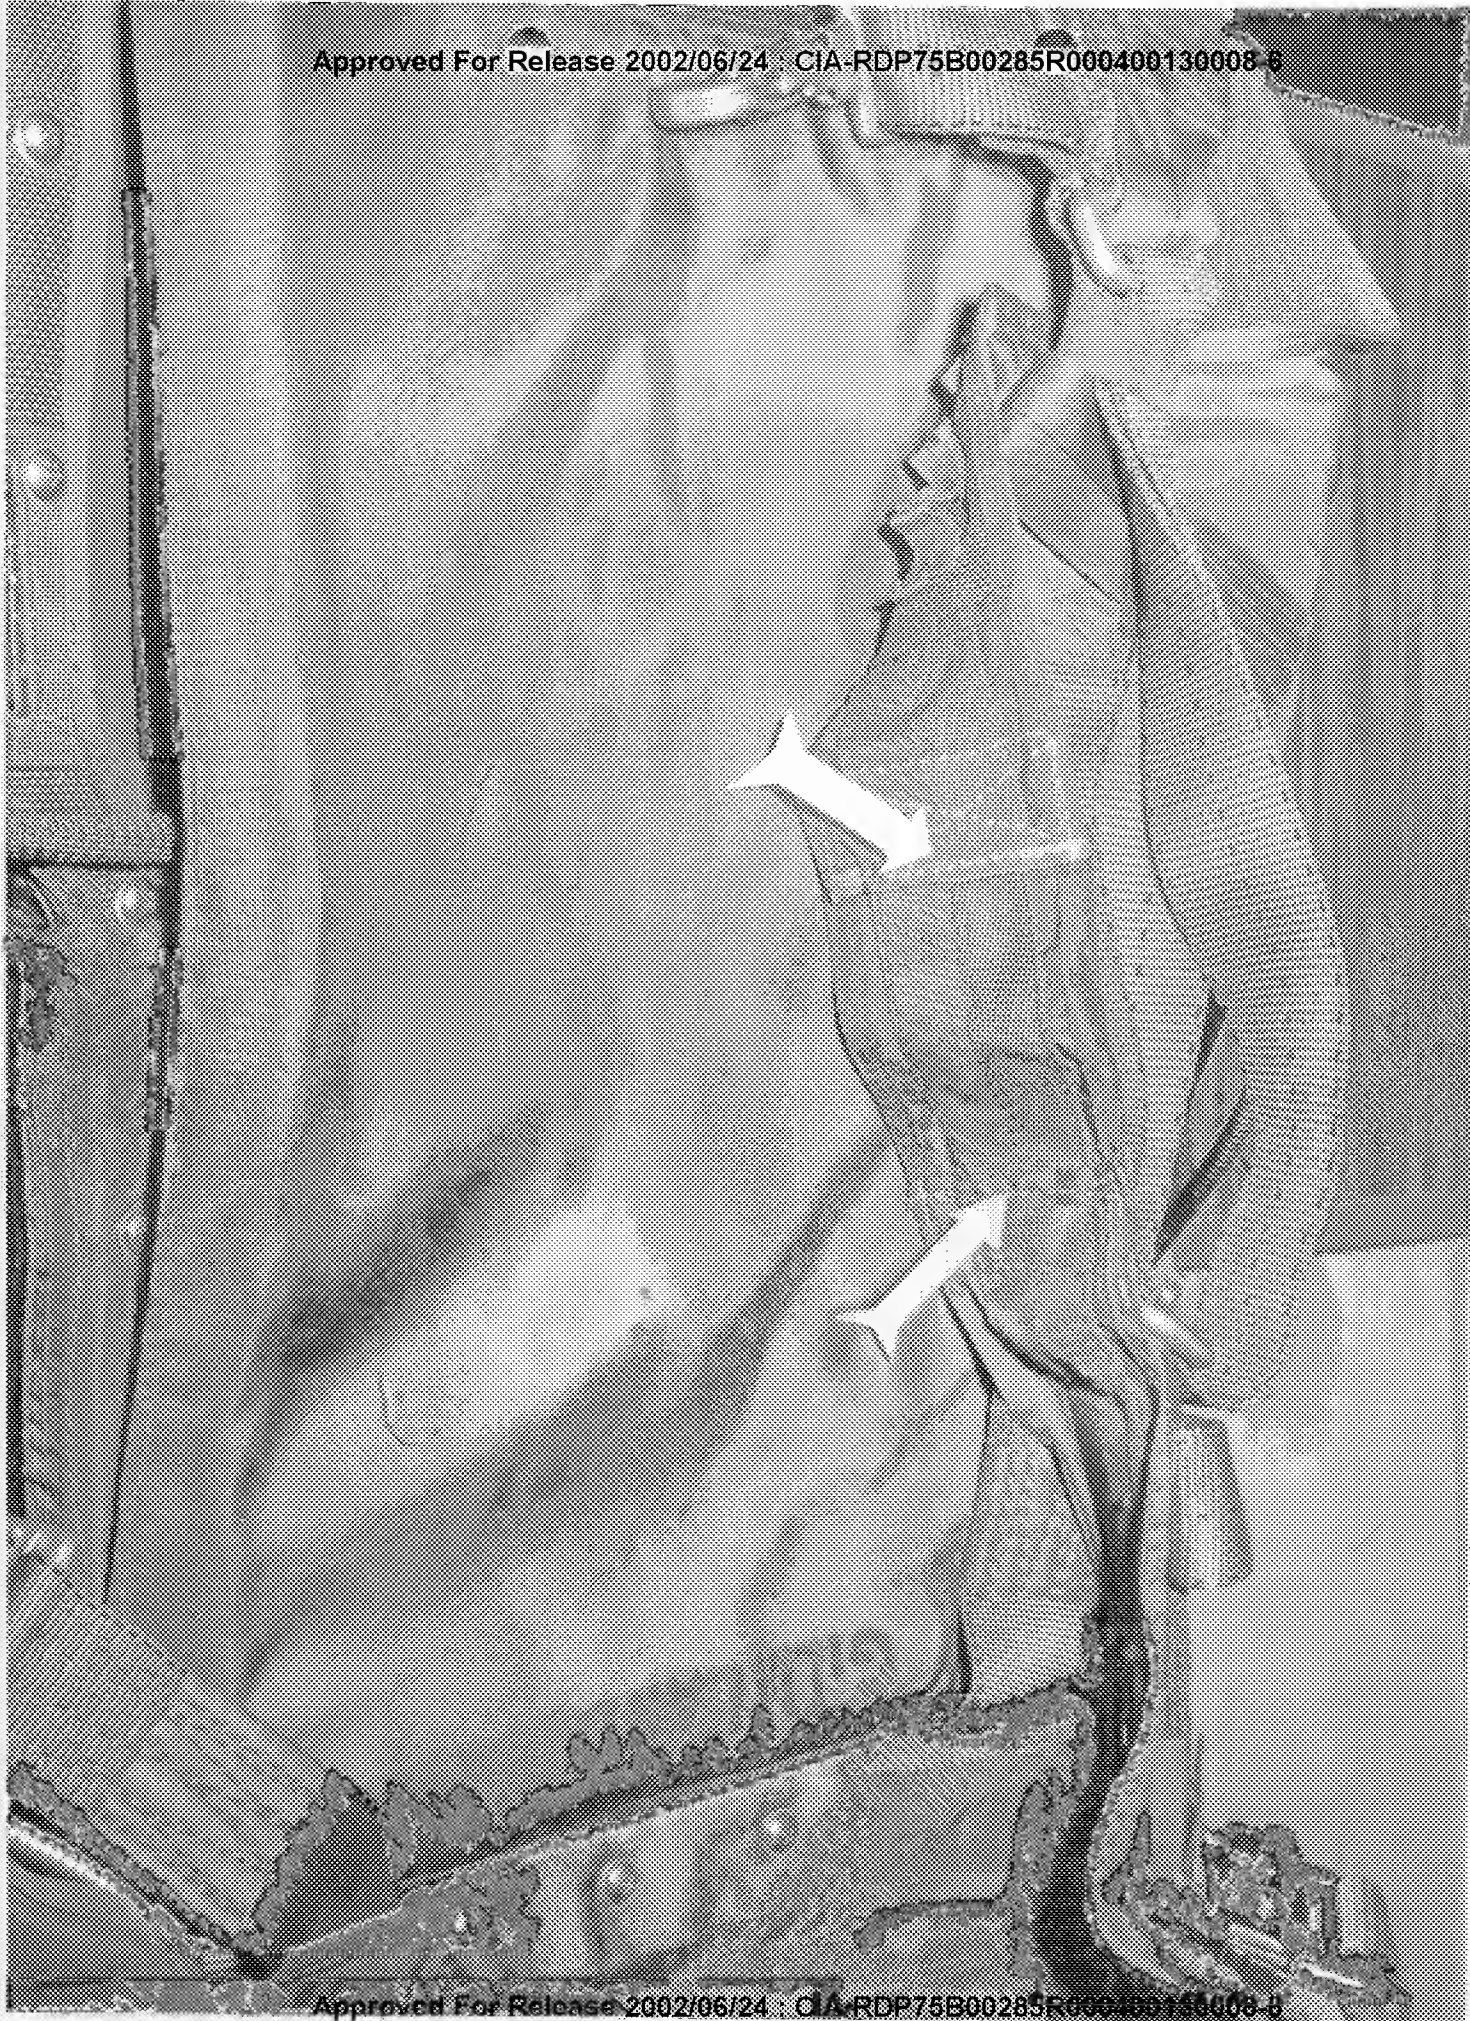
ENVELOPE # 6115 - /
REF NO. 184/13
DATE DEC 14 1967
ON FILE
ORDERED

The modification consists of a four-inch extension to the non-structural fabric beneath the two vertical lift webs.

Prior to the modification, the fabric limited the harness length adjustment and put intolerable pressure on Bob's shoulders.
